TYPICAL DETAILS OF CORNICE AND SILL

TYPICAL FRAMING METHODS

DRAWING PREPARED UNDER THE HOUSING PROJECT - BUREAU OF HOME ECONOMICS AND AGRICULTURAL ENGINEERING - U.S. DEPARTMENT OF AGRICULTURE AND CIVIL WORKS ADMINISTRATION, COOPERATING

CONSTRUCTION DETAILS

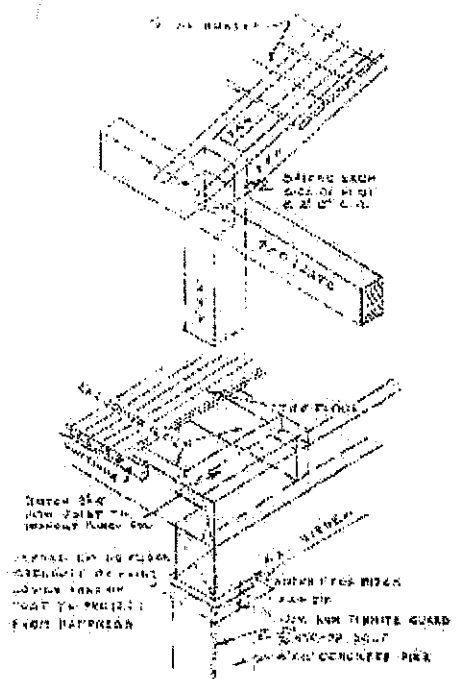
ISOMETRIC VIEW OF PORCH CORNICE & SILL CONSTRUCTION
