COOPERATIVE EXTENSION WORK IN
AGRICULTURE AND HOME ECONOMICS

TILTING CALF TABLE
PIPE FRAME

USDA '64 EX. 5969 SHEET 1 OF 2

BASED ON OREGON PLAN 64

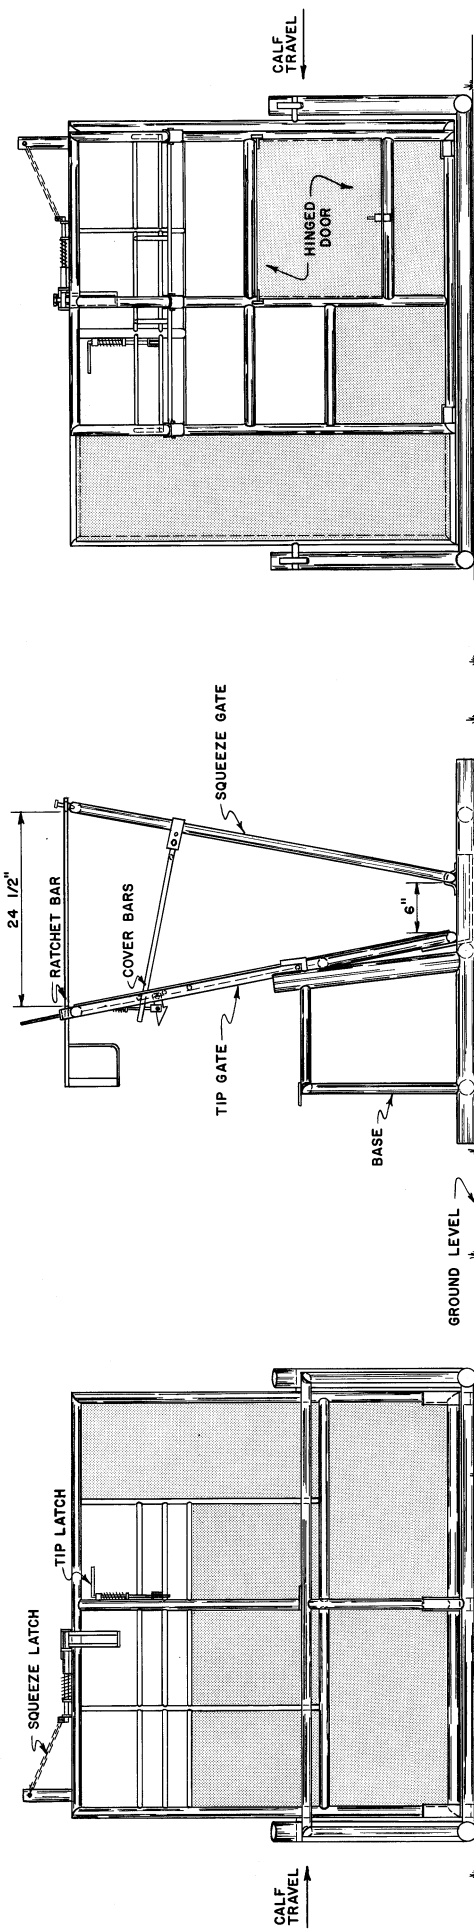
RIGHT SIDE VIEW

FRONT END VIEW

LEFT SIDE VIEW
